NPDES Inspection Report

Waste Management Disposal Services of Oregon, Inc. (Alaska Street Reload)

Seattle, Washington

March 7, 2012

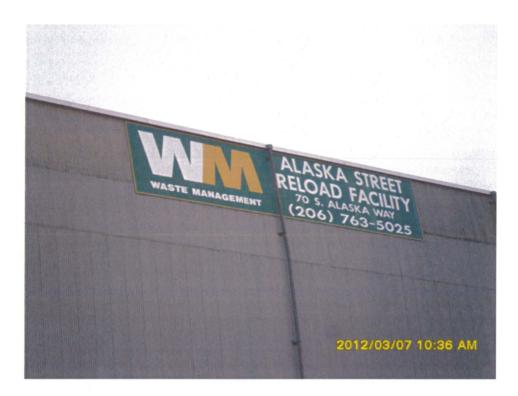
Photo #1: View of the sign at the Alaska Street Relaod facility.

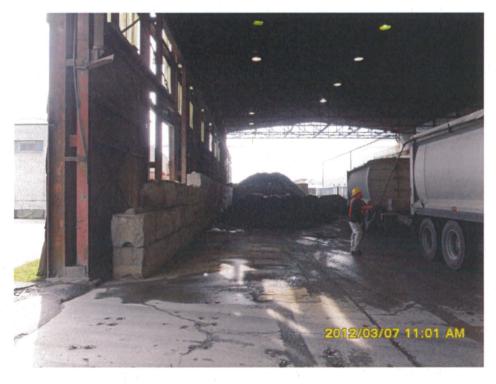
Photo #4: Southerly view showing the area just inside the entrance to the building. This building houses the contaminated materials.

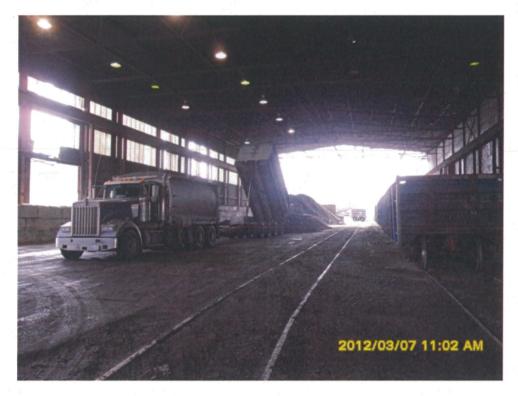
Photo #5: Another southerly view showing the inside of the contaminated material storage building.

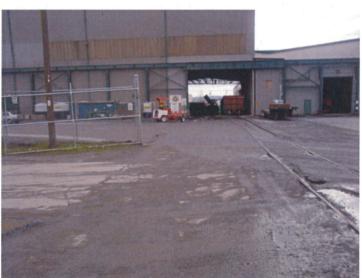
#8. <u>DESCRIPTION:</u> The storm drain catch basin seen in Photos # 3 & 4 is located is to east (left) of brown pole.

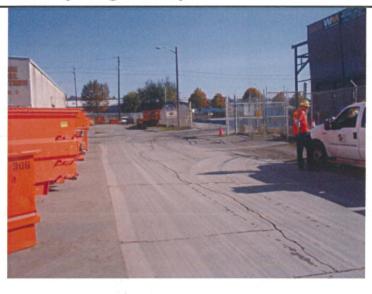
#10. <u>DESCRIPTION:</u> Seattle Public Utilities staff are assisting Ecology in the dye testing of the storm drainage system on Alaska Street.

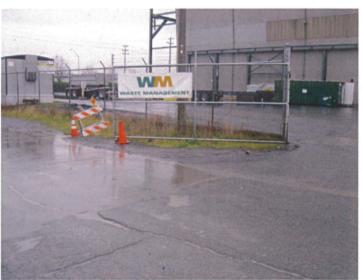
#16. DESCRIPTION: The storm drain catch basin seen in Photo # 15 is located next to white striped orange cone near the barricade.

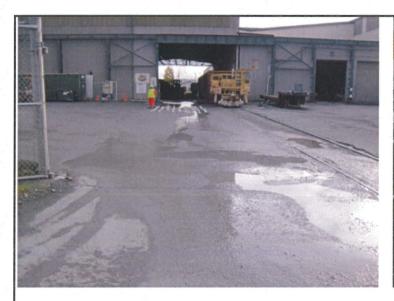
#21. <u>Description:</u> The wheel wash system is located between the staff person and the yellow machine (at the exit of the dirt handling building).
